INDOOR AIR QUALITY ASSESSMENT

**Department of Children and Families Office
810 Memorial Drive
Cambridge, MA**

Prepared by:
Massachusetts Department of Public Health
Bureau of Environmental Health
Indoor Air Quality Program
December 2016

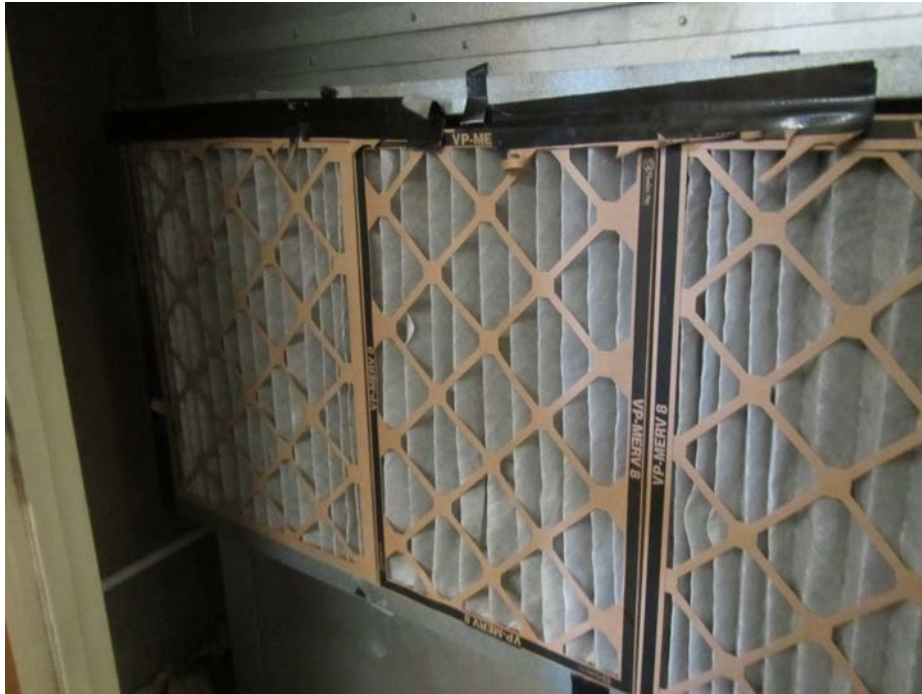
Picture 1

Fresh air is provided by air handling units (AHUs), at least one of which is located in a closet on this floor (Picture 1). Air from the AHUs is filtered, heated/cooled, and delivered to rooms via ducted supply vents (Pictures 2 and 3). Air is returned/exhausted through vents in the walls or ceiling.

Air handling unit in a closet; note MERV 8 filters sealed on with tape

22. Change filters on AHUs on a regular schedule at least twice a year. Repair AHU filter racks so that filters fit tightly without need for tape.
23. Clean carpeting in accordance with IICRC recommendations (IICRC, 2012).

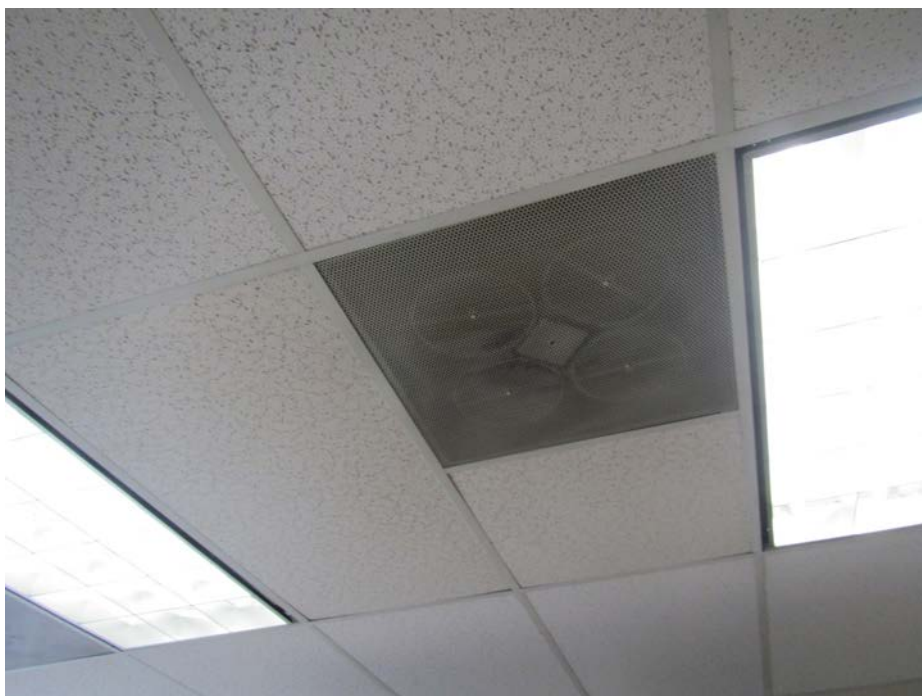
Picture 2

One style of supply vent

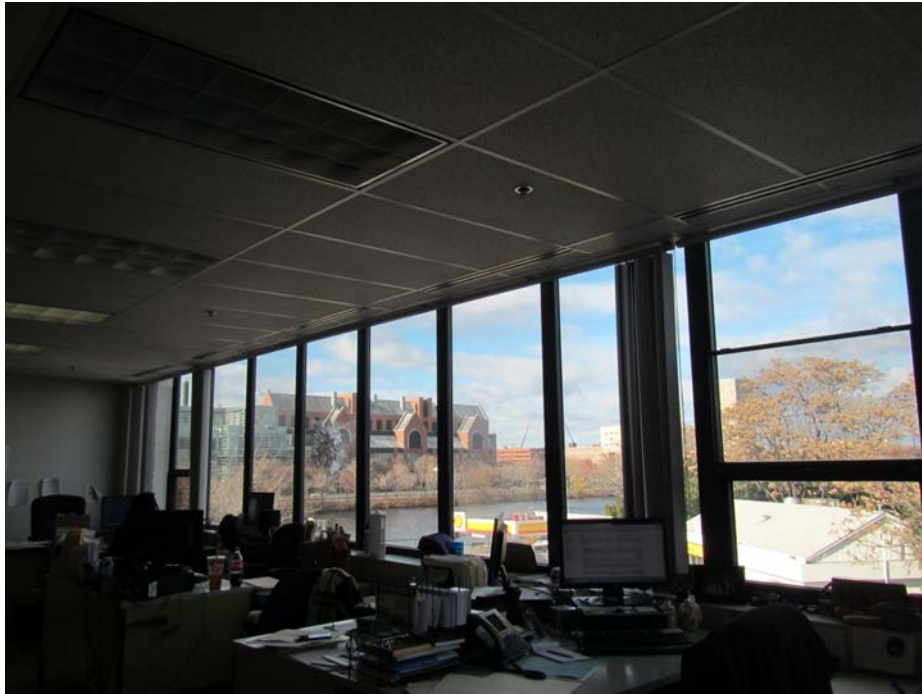
Picture 3

Supply vents along windows

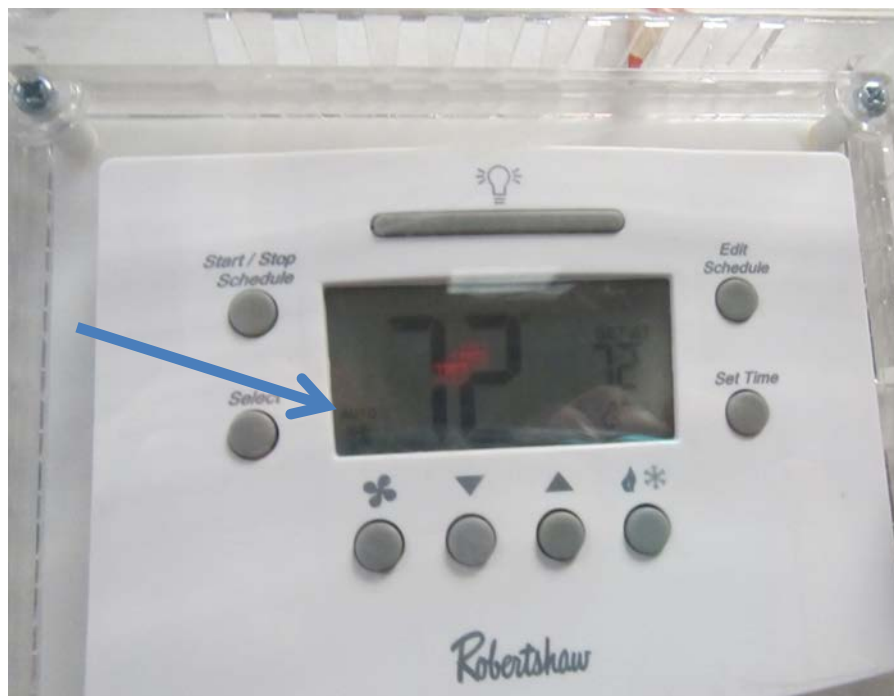
Picture 4

The assessment results indicate that the ventilation system is providing adequate fresh air for the occupancy in the building. In some areas assessed, the thermostats were observed to be set to the “fan auto” setting (Picture 4), which does not provide a continuous source of fresh air; the “fan on” setting is preferred in occupied areas.

Thermostat in clear plastic case with fan set to “auto” (arrow)

Note that the thermostats examined were covered by plastic boxes to prevent unauthorized use. The box covering the thermostat in the Legal area described above was opaque, which prevents the operating conditions from being monitored. It is recommended that this opaque box be replaced with a clear one (e.g., Picture 4).

3. Replace the opaque plastic box over the thermostat near the Legal office with a clear plastic box such as that shown in Picture 4.
4. Have the HVAC system balanced every 5 years in accordance with SMACNA recommendations (SMACNA, 1994).

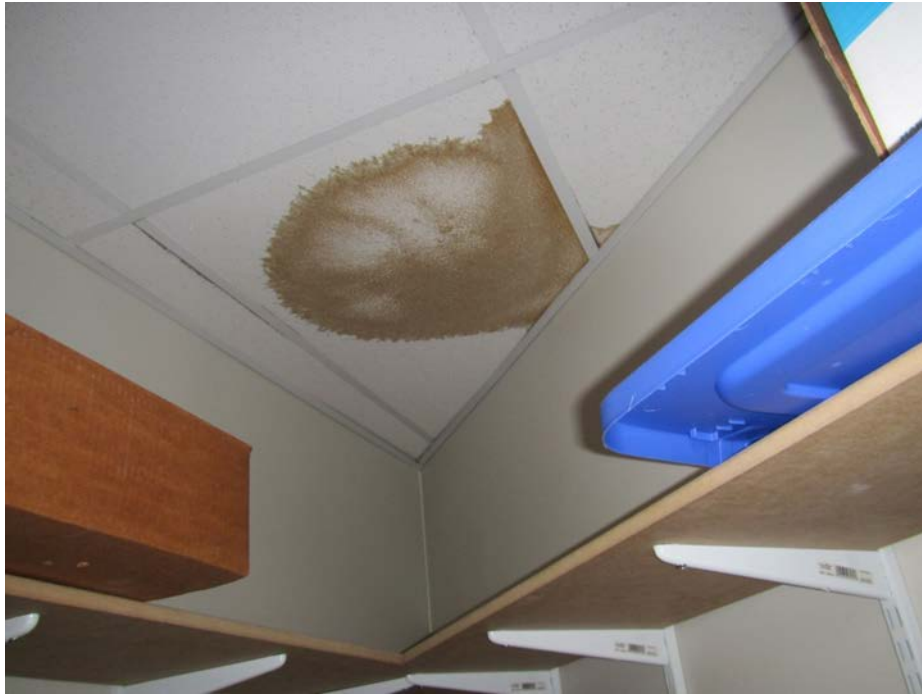
Picture 5

One of the issues that this visit was requested to address was water damage. Note that above the offices on the DCF floor are many floors of residential units. Periodic floods from plumbing malfunctions on the floors above have caused water to leak into DCF spaces in the past. At the time of the visit, water-damaged ceiling tiles (Picture 5), water-stained walls (Picture 6) and rusted fittings (Picture 7) indicating past water exposure, were observed in many locations, particularly along interior partition walls. It was reported that many stained tiles had been removed recently subsequent to the most recent water damage incident, as well as some carpet squares that had gotten wet.

Water-damaged ceiling tile

7. Replace all stained ceiling tiles, and wash water-stained walls. This will also make detecting leaks easier.

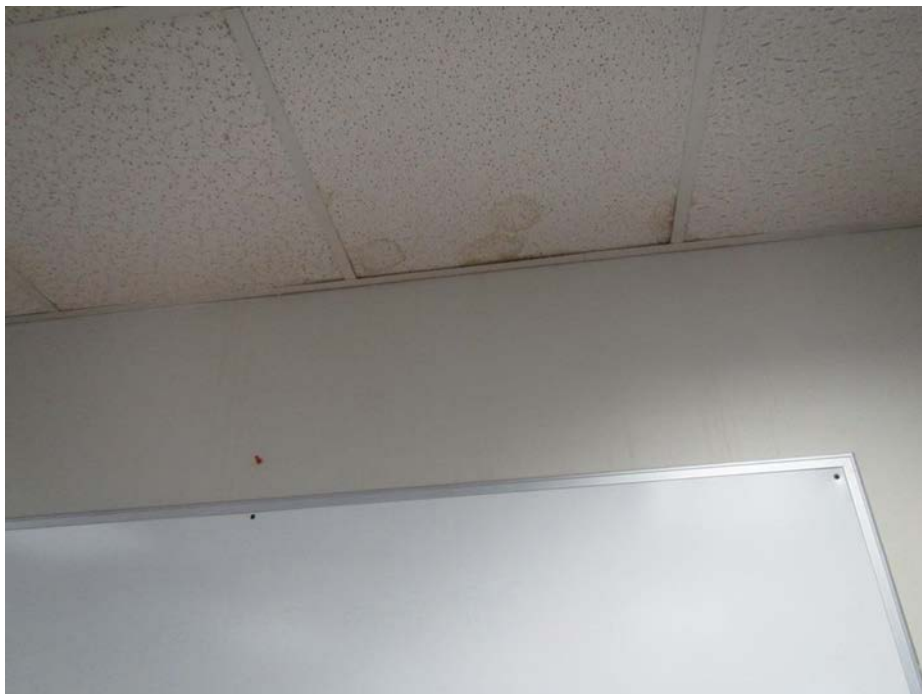
Picture 6

No damp or mold-colonized materials were observed, however in one conference room, a large whiteboard was attached to a wall that had significant water streaks (Picture 6) and it is possible that moisture had gotten behind this and not sufficiently dried. The whiteboard should be removed during an unoccupied period to check behind it for water damage and remediate as necessary.

Water-stained ceiling tiles and streaks on wall, note whiteboard attached to wall

8. During an unoccupied period, have the whiteboard located in Conference room 2 removed from the wall and check the back of the whiteboard and the wall for dampness, mold colonization and moldy odors. If any such conditions exist, discard the whiteboard and remediate damaged wallboard.

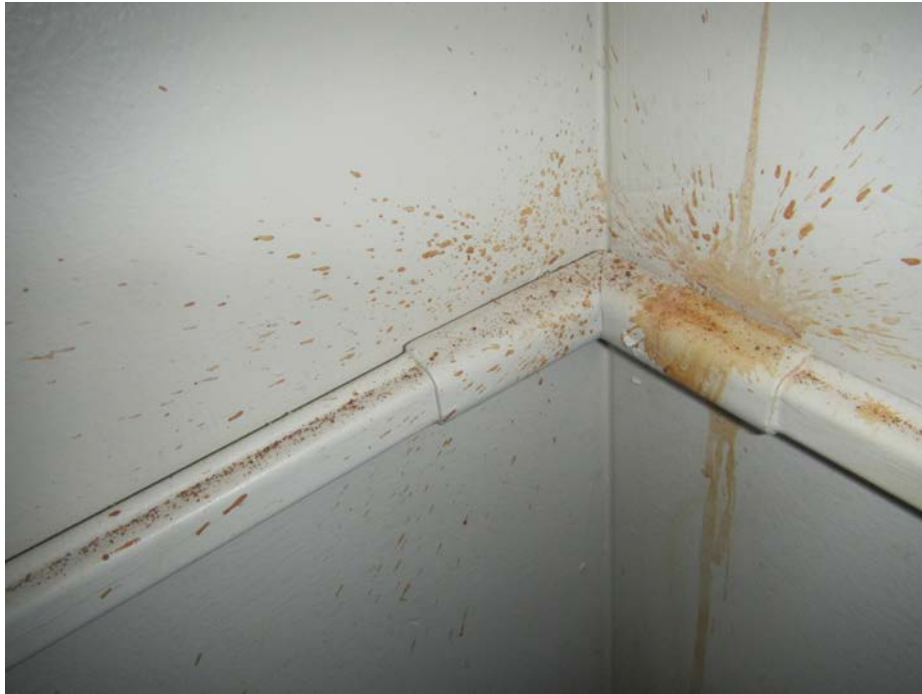
Picture 7

Water and rust stains on wall and fittings

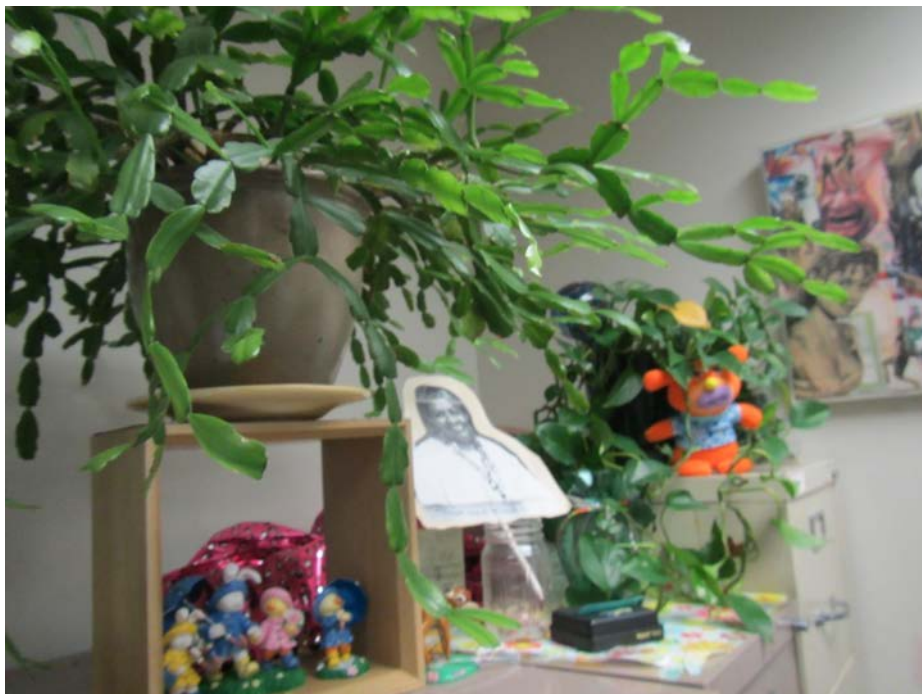
Picture 8

Plants were observed in office areas (Table 1; Pictures 8 and 9). Plants can be a source of pollen and mold, which can be respiratory irritants to some individuals. Plants should be properly maintained and equipped with drip pans to prevent water damage to porous materials. Plants should also be located away from air diffusers to prevent the aerosolization of dirt, pollen, and mold. Some of the plants were in poor condition (e.g., dead) and should be removed.

Plants on an office shelf

9. Given that leaks may occur again, avoid storing materials on the floors or up against walls to avoid water damage.
10. Keep indoor plants in good condition, avoid overwatering, and avoid placing them on porous items such as carpets or paper. Also, keep plants out of the air stream of supply vents.

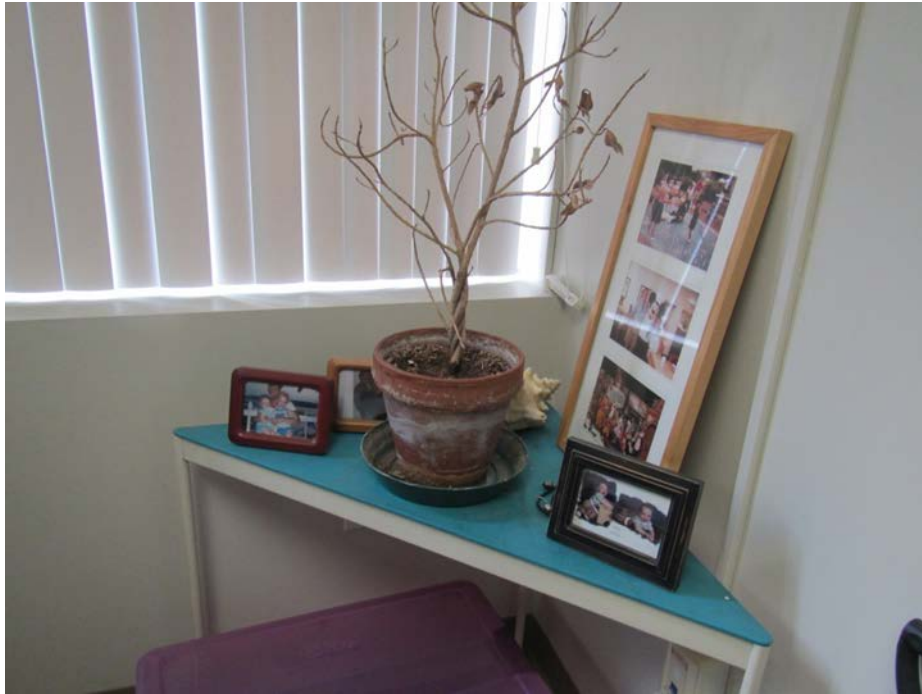
Picture 9

Dead plant

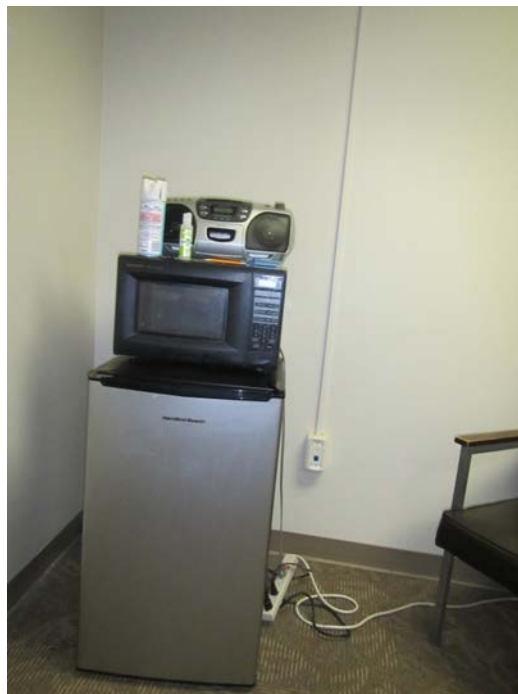
Picture 10

Small refrigerators and water dispensers were observed in carpeted areas (Table 1; Picture 10). These appliances may spill or leak and lead to carpet damage and microbial growth. It is recommended that these appliances be located in areas without carpeting or on waterproof mats. Carpet squares could also be replaced with tile in areas where water dispensers and refrigerators are located. Refrigerators should be kept clean to prevent odors and microbial growth.

IPM also includes removal of sources of food, water and harborage for pests. Cooking equipment, including toasters, microwave ovens and coffee machines were located in various parts of the office space (Table 1; Picture 10). The presence of so many different pieces of cooking equipment near workstations and without direct exhaust ventilation also increases the chance of food odors permeating office areas. Food areas and cooking equipment need to be kept clean to prevent odors and pests. Carpeting in these areas may trap crumbs and spills as well. Consider consolidating cooking areas into unoccupied and uncarpeted areas or protect the carpeting in these areas with a mat. Food was observed stored in the open (Picture 18); all food should be stored in pest-proof containers.

Refrigerator on carpet, note microwave and cleaning products

11. Consider moving refrigerators and water dispensers to areas without carpeting or place them on a waterproof mat.
12. Clean refrigerators out regularly to avoid odors and microbial growth.

17. Ensure cooking areas/equipment are kept clean to prevent odors and pests. Consider reducing the number of areas where food is stored and locating them away from occupied areas. Store all food in pest-proof containers.

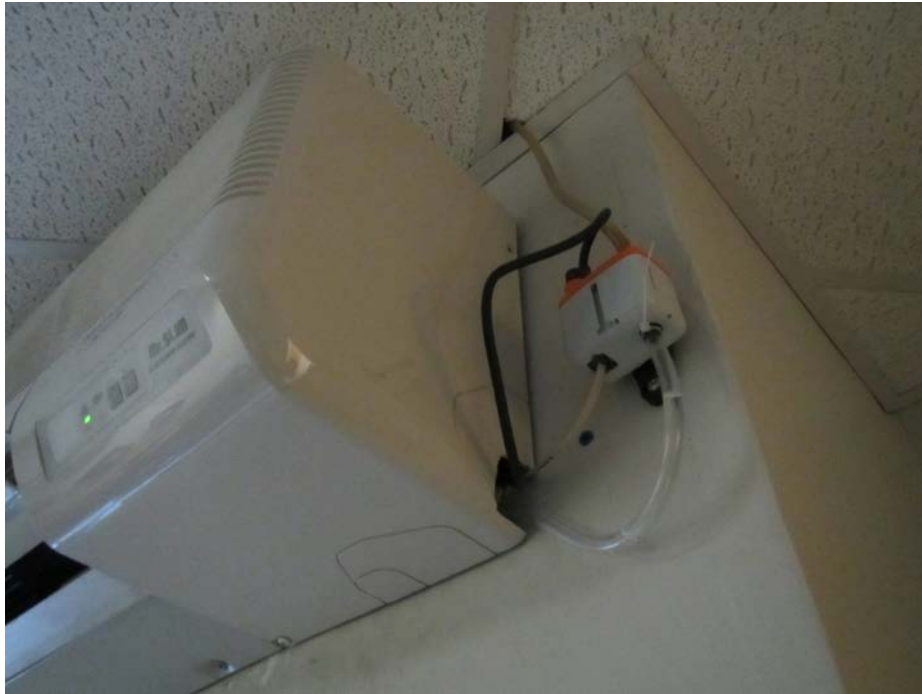
Picture 11

A ductless air conditioning unit was observed in the IT room (Picture 11). The condensate pump and piping that connect this unit with a drain should be inspected periodically for clogs and leaks to prevent water damage to nearby building materials. Note that the curve of the piping has trapped some water inside, which can become stagnant during colder weather when the unit does not need to operate consistently; if possible this pipe should be sloped to drain completely. A chilling unit was seen in a maintenance closet (Picture 12) which also had a condensate pump.

Ductless air conditioner in IT room; note water in drainage tube

13. Inspect condensate pumps and piping for ductless air-conditioning and other chilling units regularly for clogs and leaks.
14. Continue to work with a pest control contractor to control roaches in the trash chute room.

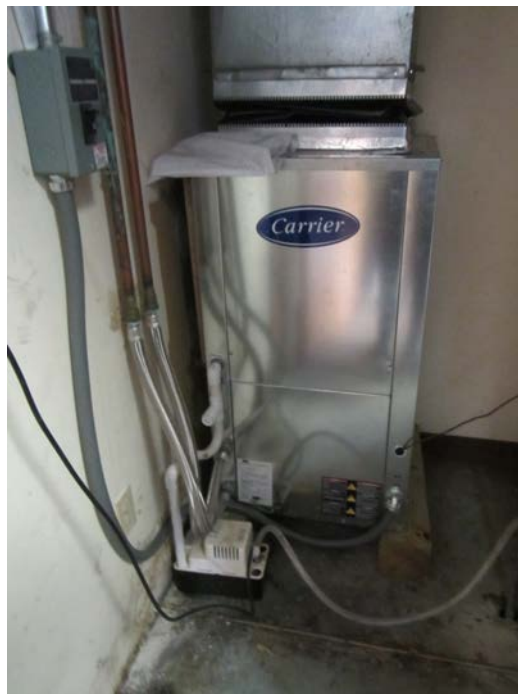
The door to the closet with the chilling unit shown in Picture 12 had a coating of dust (Picture 19) that indicates that air is being drawn into this closet. The function of this unit should be investigated, as no obvious air intakes/returns were observed. If it requires a source of make-up air, a vent should be cut into this door to supply a free flow of air. If no air should be drawn into this unit, any gaps or leaks should be repaired. There were also holes in the wall and missing ceiling tiles in this room. The dust shown in Picture 19 should be cleaned to prevent reaerosolization.

Chilling unit with condensate pump

19. Investigate the function of the chilling unit shown in Picture 12. If it requires a source of make-up air to function, have the door to this room undercut or install a vent in it. If it should not be drawing air, have it repaired. Seal all holes in walls and maintain an intact ceiling in this room.

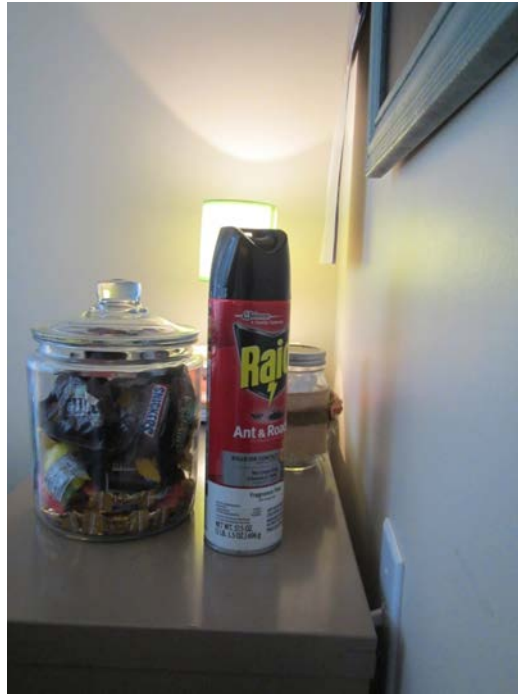
Picture 13

Can of pesticide and jar of food

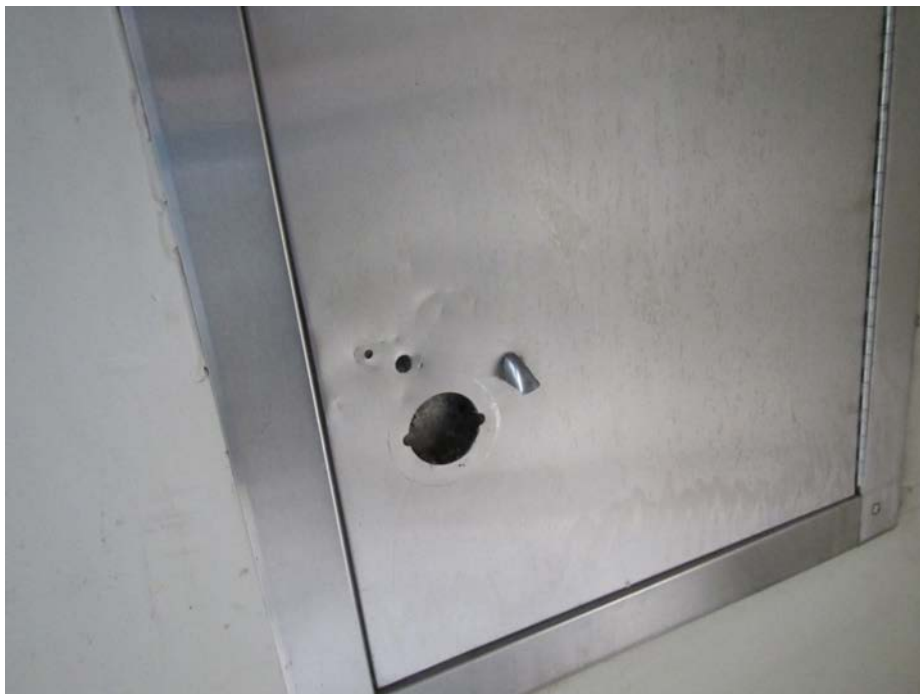
Picture 14

Issues with pests were reported in this office. The residential portion of the building is equipped with a trash chute that passes through a room behind a storage area (Pictures 14 and 15). Roaches and odors were reported emanating from this trash chute area into occupied spaces. Reportedly, the building management had the chute cleaned and sanitized in response to this issue, as well as using the services of a pest control company. However, as shown in Picture 15, roaches are still present in this area. Pest control should be continued, as well as both the building management and occupants following the other principles of integrated pest management (IPM). Note that IPM includes “exclusion” such as ensuring the walls of this room are free of holes and gaps (e.g., Picture 16) and the installation of tight weather-stripping at the base of the door between the trash room and the storage area (Picture 17).

Door to trash chute (not openable on this level)

15. Ensure that a regular, scheduled cleaning/sanitizing of the trash chute occurs.
16. Have all gaps in the walls in the trash chute room sealed with an appropriate sealant. Have stiff, tightly fitted weather-stripping installed underneath the door between the trash chute room and the storage area and monitor for visible light underneath.

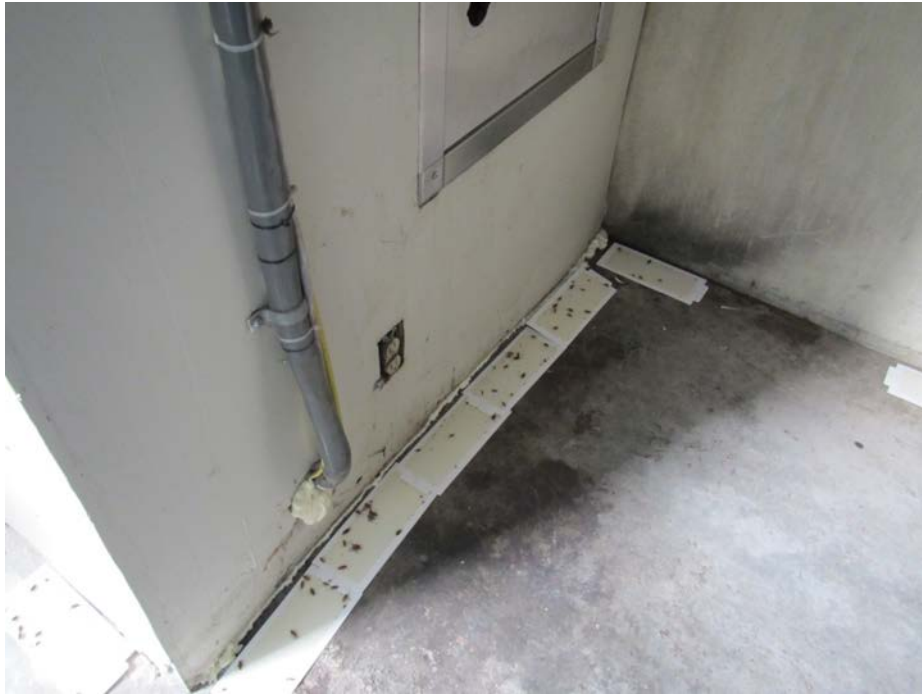
Picture 15

Glue traps with roaches next to trash chute door

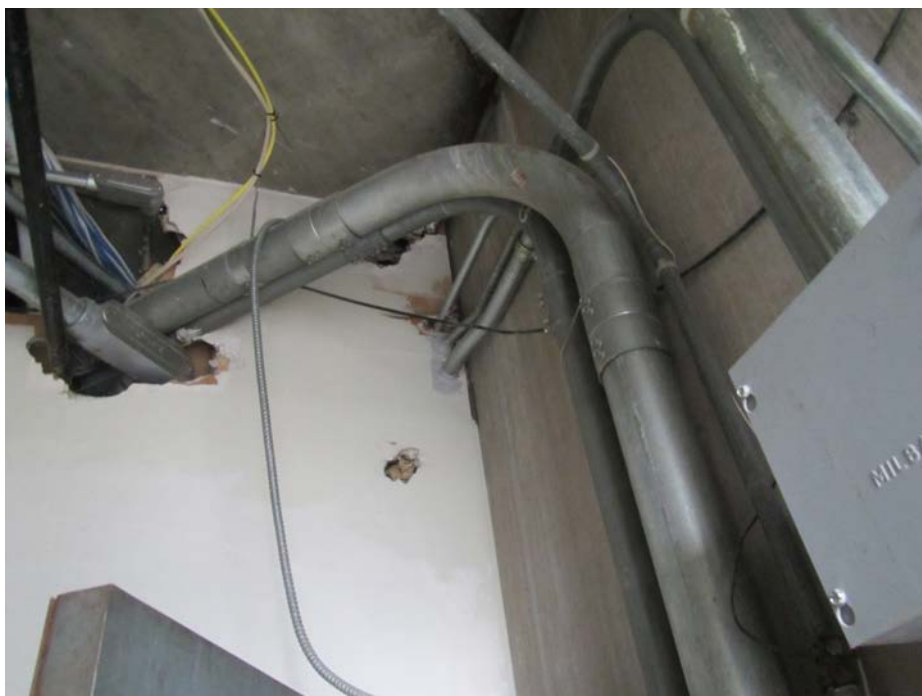
Picture 16

Holes in wall in trash chute room

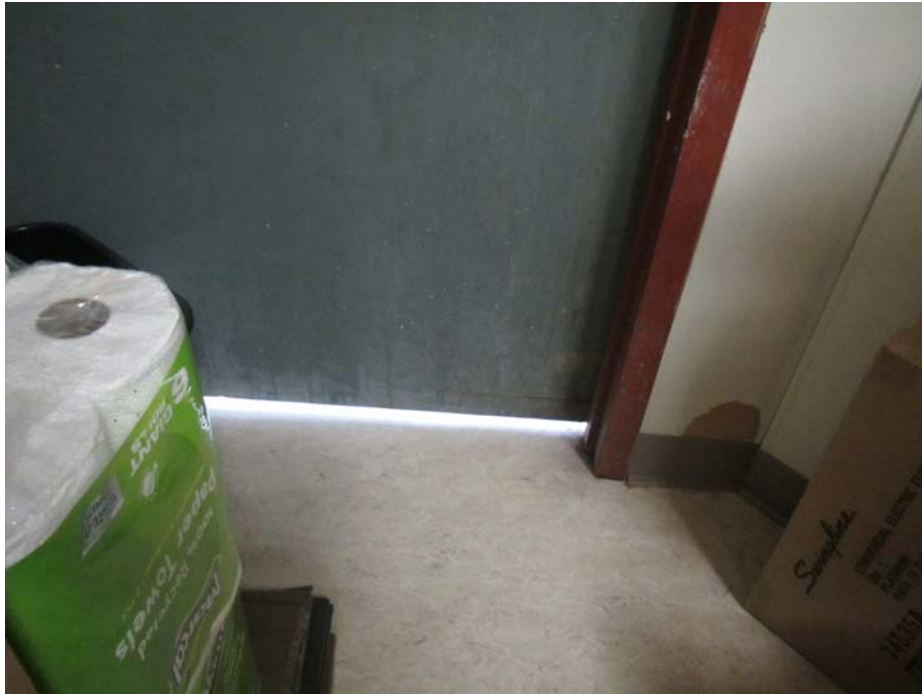
Picture 17

Door to trash chute room as seen from storage room, note large gap under door

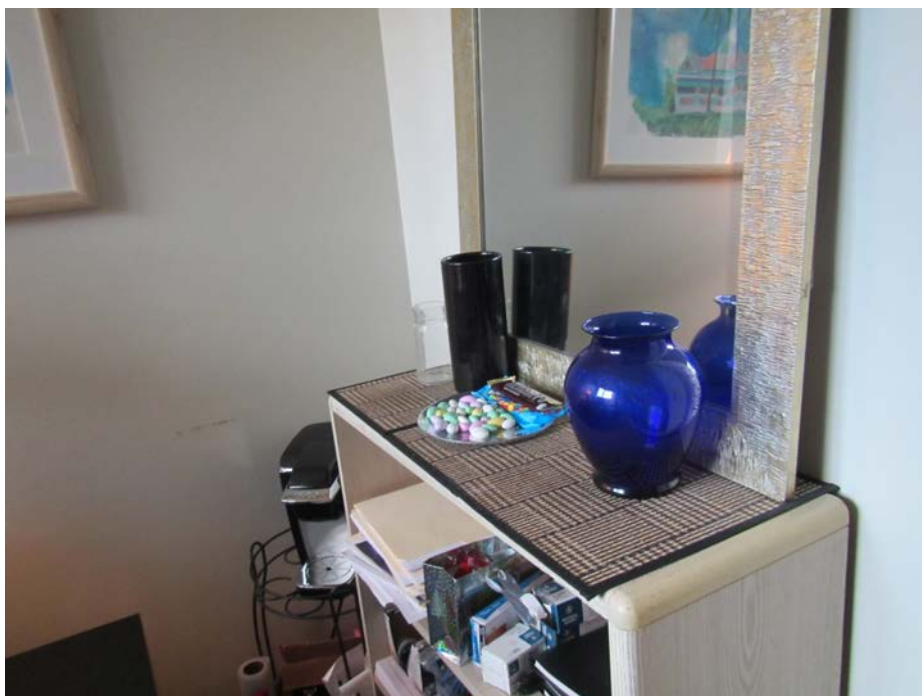
Picture 18

Food left out in the open

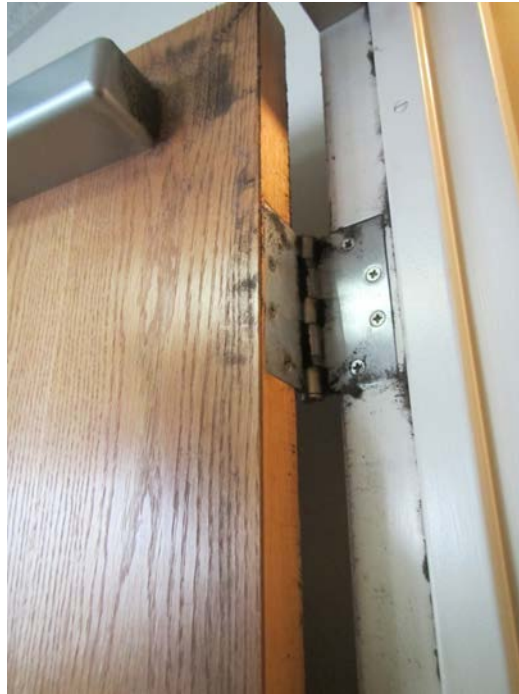
Picture 19

Dust along edges of door to chiller room

20. Clean the dust from the door edges in the chiller room.
21. Store items in storerooms neatly to allow for thorough cleaning and to prevent creating harborage for pests,

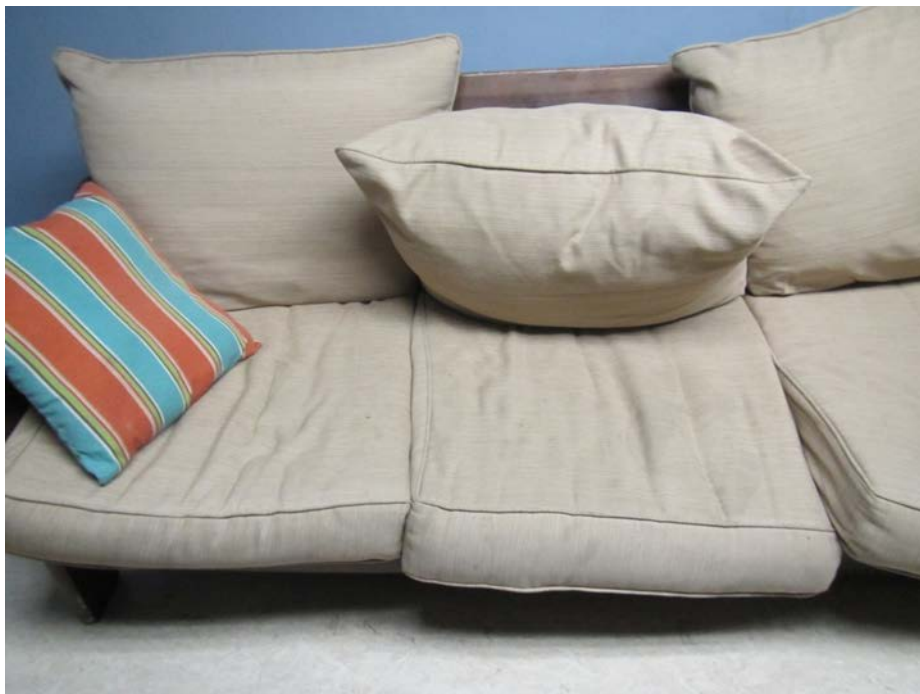
Picture 20

Upholstered furniture was observed in several offices and visitation rooms (Picture 20). Upholstered furniture, pillows and cushions are covered with fabric that comes in contact with

human skin. This type of contact can leave oils, perspiration, hair and skin cells. Dust mites feed upon human skin cells and excrete waste products that contain allergens. In addition, if relative humidity levels increase above 60 percent, dust mites tend to proliferate (US EPA, 1992). In order to remove dust mites and other pollutants, frequent vacuuming of upholstered furniture is recommended (Berry, M.A., 1994). It is also recommended that upholstered furniture be professionally cleaned on an annual basis or more frequently if needed.

Upholstered furniture

26. Clean upholstered furniture, cloth curtains, stuffed animals, and pillows on a regular schedule. If not possible/practical, consider removing them from rooms.
